Mangrove Ecosystems and Livelihoods

Lessons From the Restoration of a Mangrove System in Point Lisas, Trinidad and Tobago (completed)

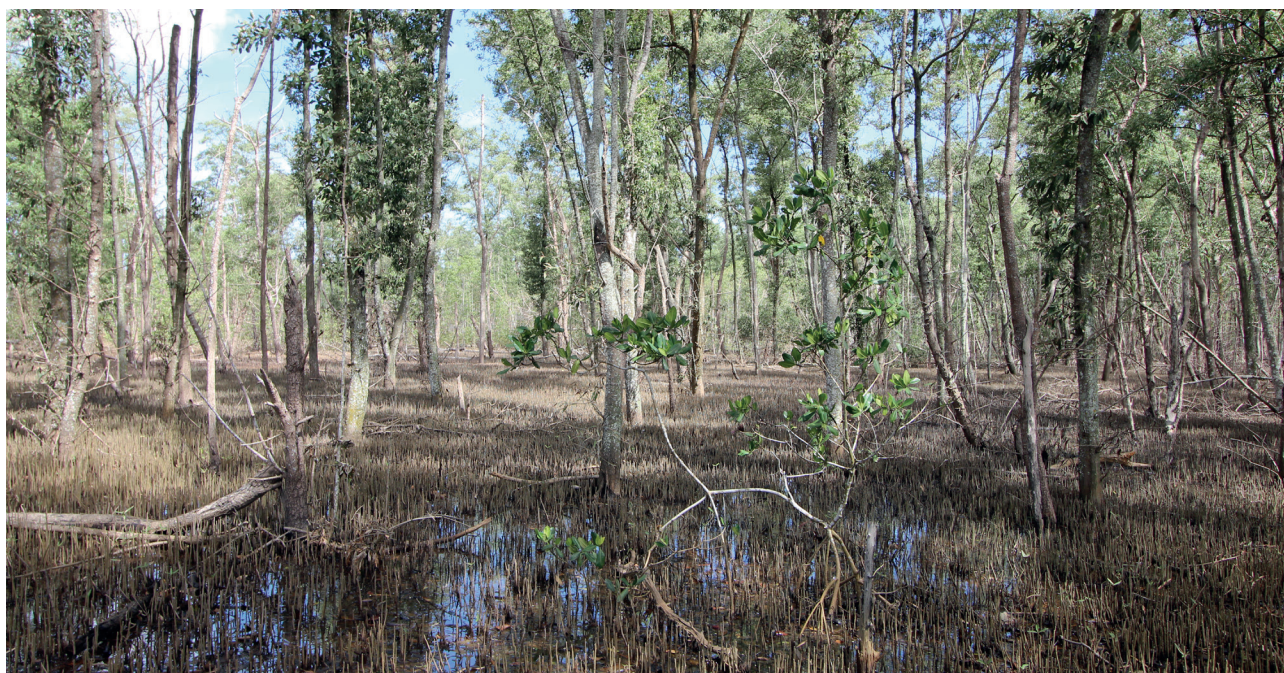
Photograph of the recovery, taken 2016. Source: Juman

By 2003, the tree density was 30 trees per 0.01 ha, with tree height between 6 and 8 m. Shortly after 2003, the area suffered mangrove die back disease, but by 2006 there had been another period of regrowth, with the tree density returning to 13 trees per 0.01 ha and an average height of almost 10 m. There have been subsequent periods of die back and regrowth in the restoration area as a result of disease and infestation. However, there has not been any further replanting since 1999 and so the system appears quite resilient.
